Šibenik Brownfield Urban Regeneration

Land Condition Appraisal

Reference: 268227-01\ISSUE4

ISSUE 4 | 17 July 2023

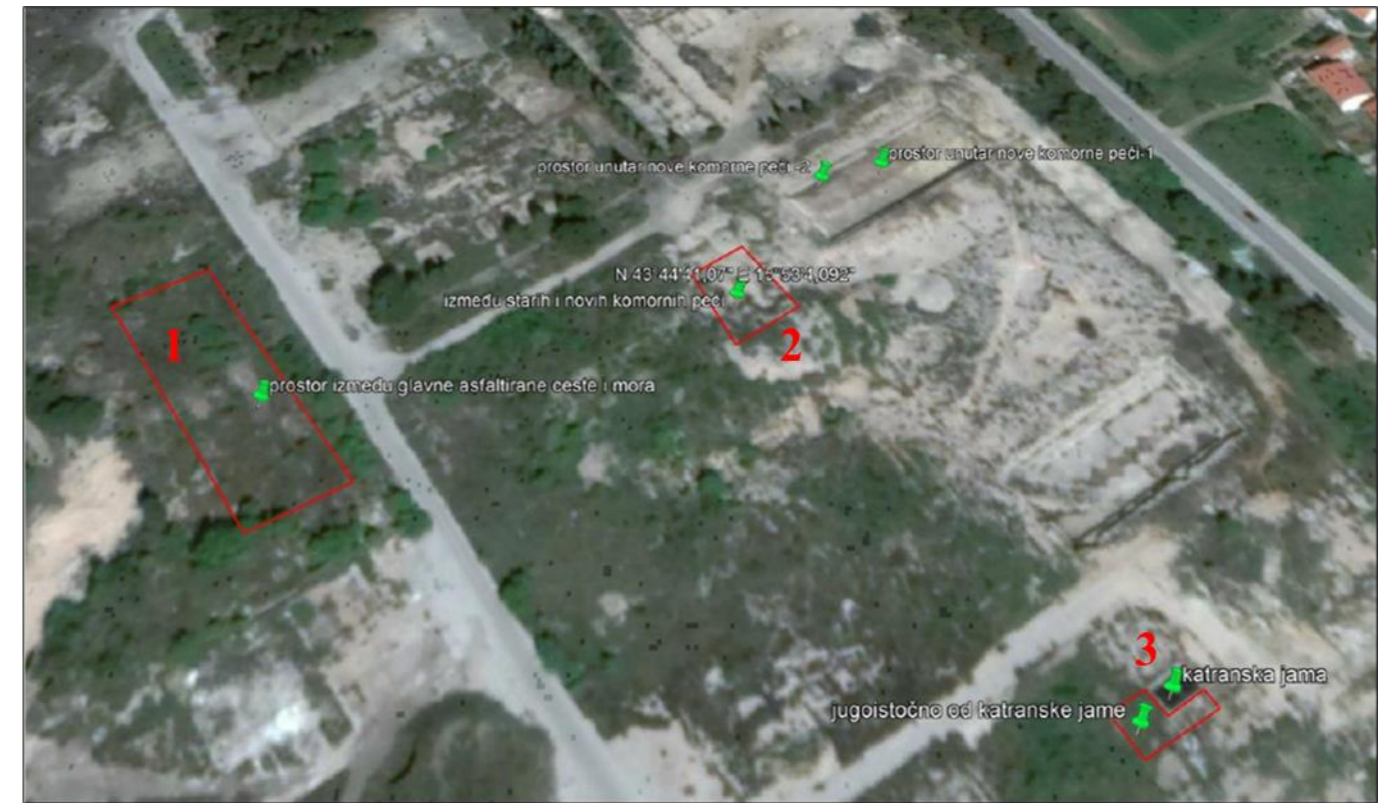
Figure 2 Areas requiring additional contaminated soil removal to achieve regulator approval (red polygons) (from Oikon 2018)

Oikon 2018 [4] recommends the following additional remediation is required and necessary to meet the standards agreed with the environmental regulator:

- Tar pit: 'It is recommended to empty the contents and remove the concrete construction of the tar pit (dimensions: 9 mx 7 m, depth 3 m, wall thickness 0.35 m). Excavation of a concrete structure can expect about 80m³ of contaminated material, that is, the excavation of a tar pit will generate hazardous construction waste. Excavation of the soil southeast of the tar pit with an area of approx. 63 m²' Oikon 2018 [4] identifies 80m³ waste from the tar pit plus 63m³ contaminated soil that is predominantly hazardous waste.

- Between the old and new chamber furnaces: Oikon 2018 [4] estimates 475m³ soil contamination to be removed as likely non-hazardous waste.
- Between the main road and coast: This area did not have any failures of the PAH validation criteria but is an area identified as potentially contaminated soil due to previous waste disposal in this area. A volume of 5400m³ requiring removal is estimated by Oikon.

The remediation works recommended by Oikon 2018 have not been completed.

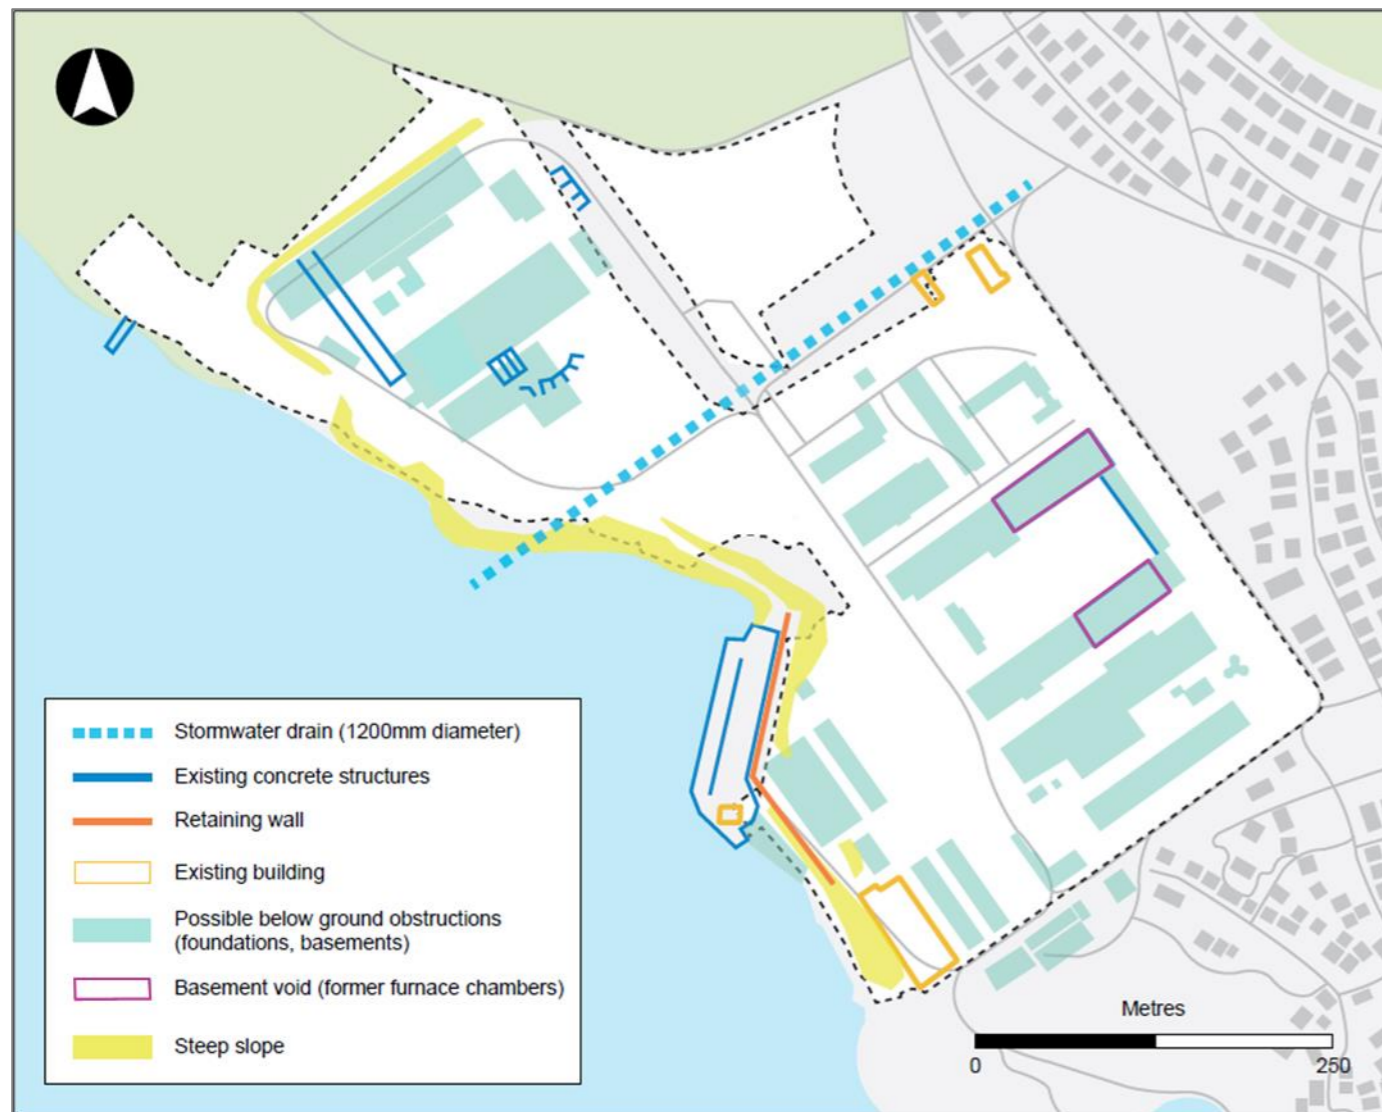
Figure 8 Geotechnical constraints plan (not contamination related)

- Below ground obstructions, such as massive concrete foundations, will be present related to previous buildings and facilities. Breaking out of below ground obstructions will be necessary where they will interfere with the proposed development, such as where site levels need to reduce (cut) or for new foundations. This concrete may also be crushed and reused as aggregate either on site or off site.

- Thick made ground (maximum c.10m thick) is present across the central and northwestern site areas. Piled foundations may be needed. In these areas excavation will be easier due to the unconsolidated character of the material. However localised soil contamination may be encountered (such as related to spills) and grossly contaminated soil will require offsite disposal (see below). Excavated soils will need to be re-used in a suitable location on site or disposed off site. If re-used in areas of soft landscaping a cover layer of clean soil will be needed (see Section 7.4).

- A large retaining wall is located east of the jetty. The structural condition of this retaining wall has not been assessed. It is not known if this retaining wall and jetty will be retained in the future development.

- A stormwater drain (1200mm diameter) traverses the site in a northeast to southwest direction. The condition of this drain has not been assessed.
- Remains of drainage networks associated with the previous industrial uses are likely to be present and are of unknown condition and extent.

- Removal and crushing of below ground obstructions (foundations and redundant utilities and furnace chambers) where necessary for future development.
- Assessment of condition of 1200mm overflow and replacement if necessary.

- Assessment of condition of retaining walls and natural steep slopes and improvement if necessary.
- Excavation and offsite disposal of the tar pit and associated contaminated soils and validation testing (against 100mg/kg total PAH validation criteria) [REMEDICATION]
