Šibenik Brownfield Urban Regeneration

Land Condition Appraisal

Reference: 268227-01\ISSUE4

ISSUE 4 | 17 July 2023

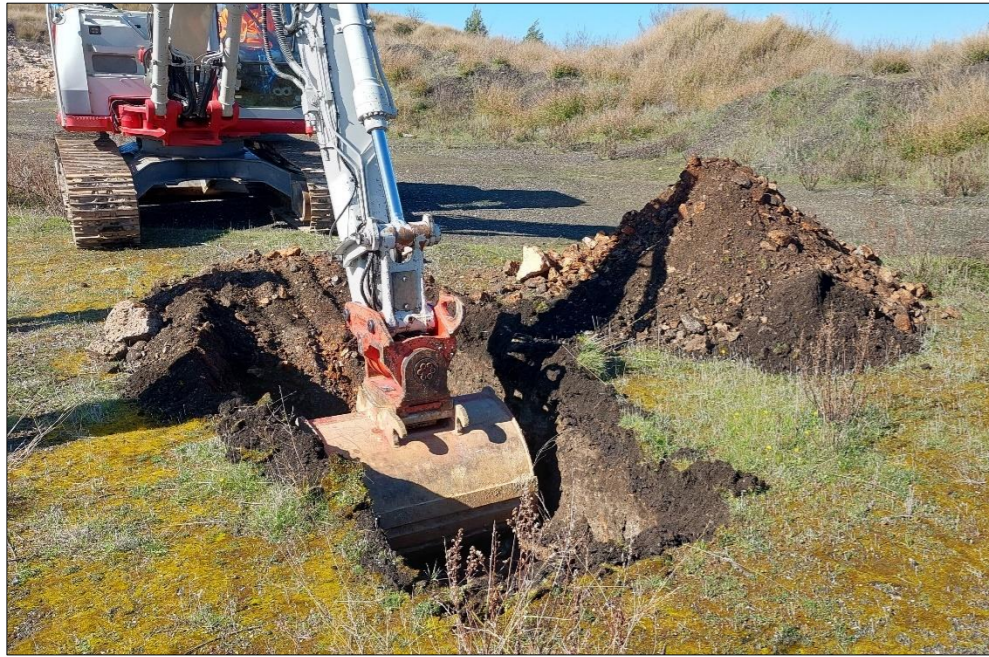
Figure 3 Excavation of trial pit TP-5

Eight trial pits were created by mechanical excavator, as shown in Figure 3. Soil samples were taken near surface (0.1-0.2m depth) in all trial pits and a second sample between 0.25 and 2m depth. A third sample was taken in TP-8 only at 2.5 to 3.0m depth. Fourteen samples in total were collected from trial pits.

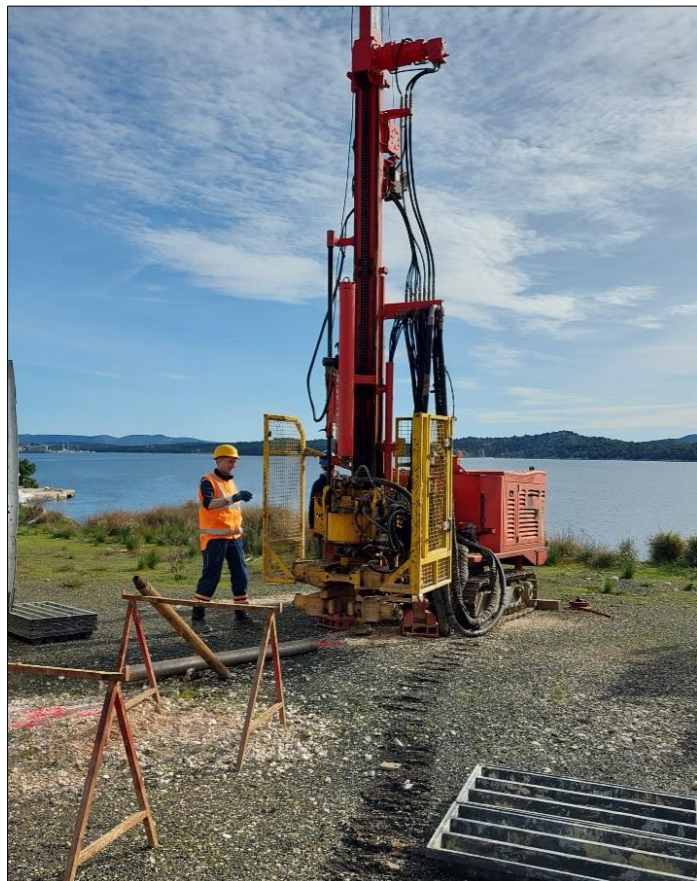
Figure 4 Drilling at borehole BH-4

The five boreholes were drilled using rotary coring technique, as shown in Figure 4. Up to three samples were collected from each borehole for laboratory analysis, depending on the thickness of superficial deposits encountered. Bedrock samples were not sampled for chemical testing.

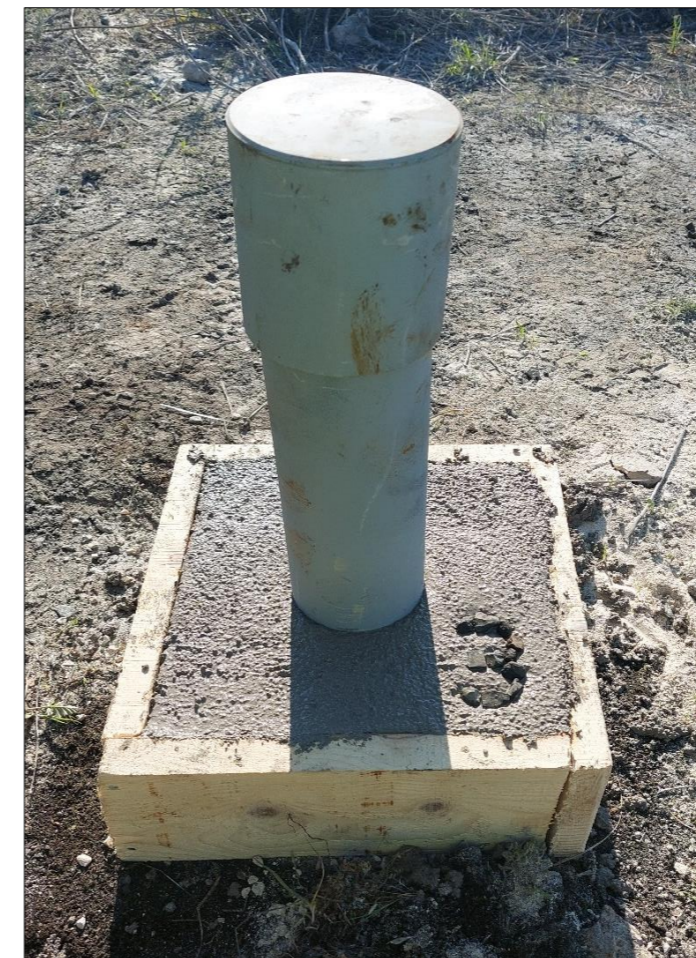
Figure 5 Lockable steel cover at borehole BH-3

Permanent headworks comprising a lockable steel cover, concreted in place, were constructed to protect each well, as shown in Figure 5.

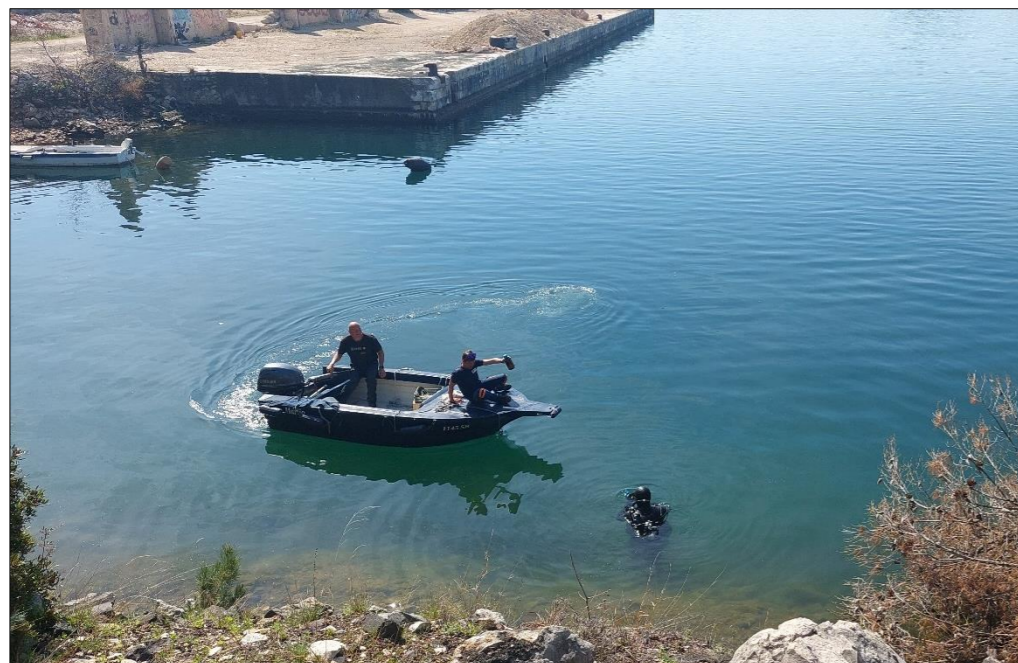
Figure 6 Marine sampling at location SEDIMENT-4

Marine sediment and seawater sampling was undertaken by a diver operating from a small boat as shown in Figure 6.

The subsurface topography was identified by the diver as steeply sloping. Marine sediment samples were taken from the upper 10cm of marine sediment, beneath seawater of 3.5 to 7.5m depth. Seawater samples were taken from the same location at mid column depth, typically around 2m depth.

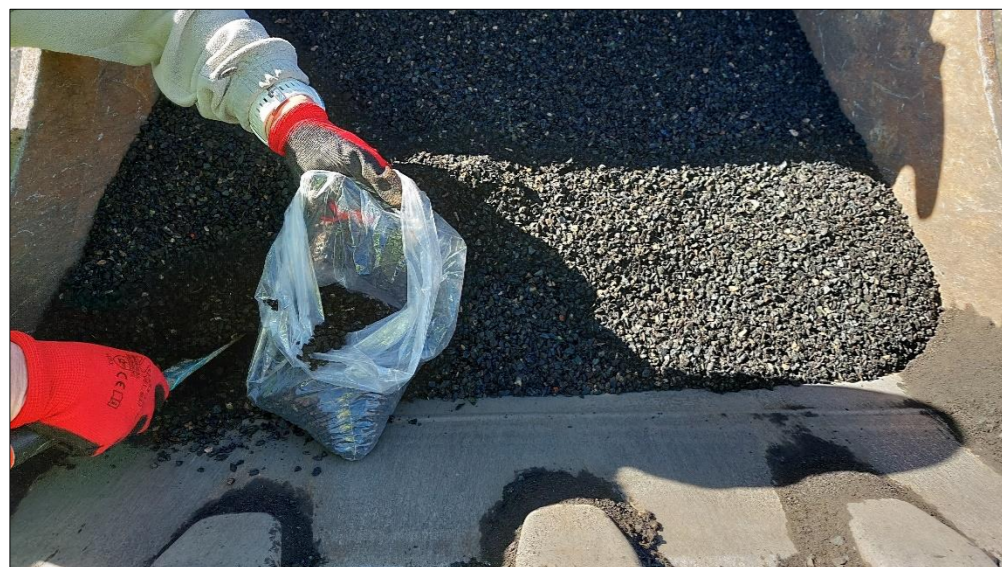
Figure 7 Sampling slag from excavator bucket

Samples of slag were collected from four locations across the site where a large stockpile of material is present, shown on Drawing 3. The mechanical excavator was used to excavate slag from 0.2m depth and a sample collected from the excavator bucket as shown in Figure 7.
